Corrosion Report

Equipment Location ID 0955-003-001
Equip. Location Descrip. C-1100 OVHD

**CHEVRON
RICHMOND FACILITY
AUT REPORT
CRUDE OVERHEAD
LINE
APRIL 2011**

Crude unit overhead line inspection 5/11/2011

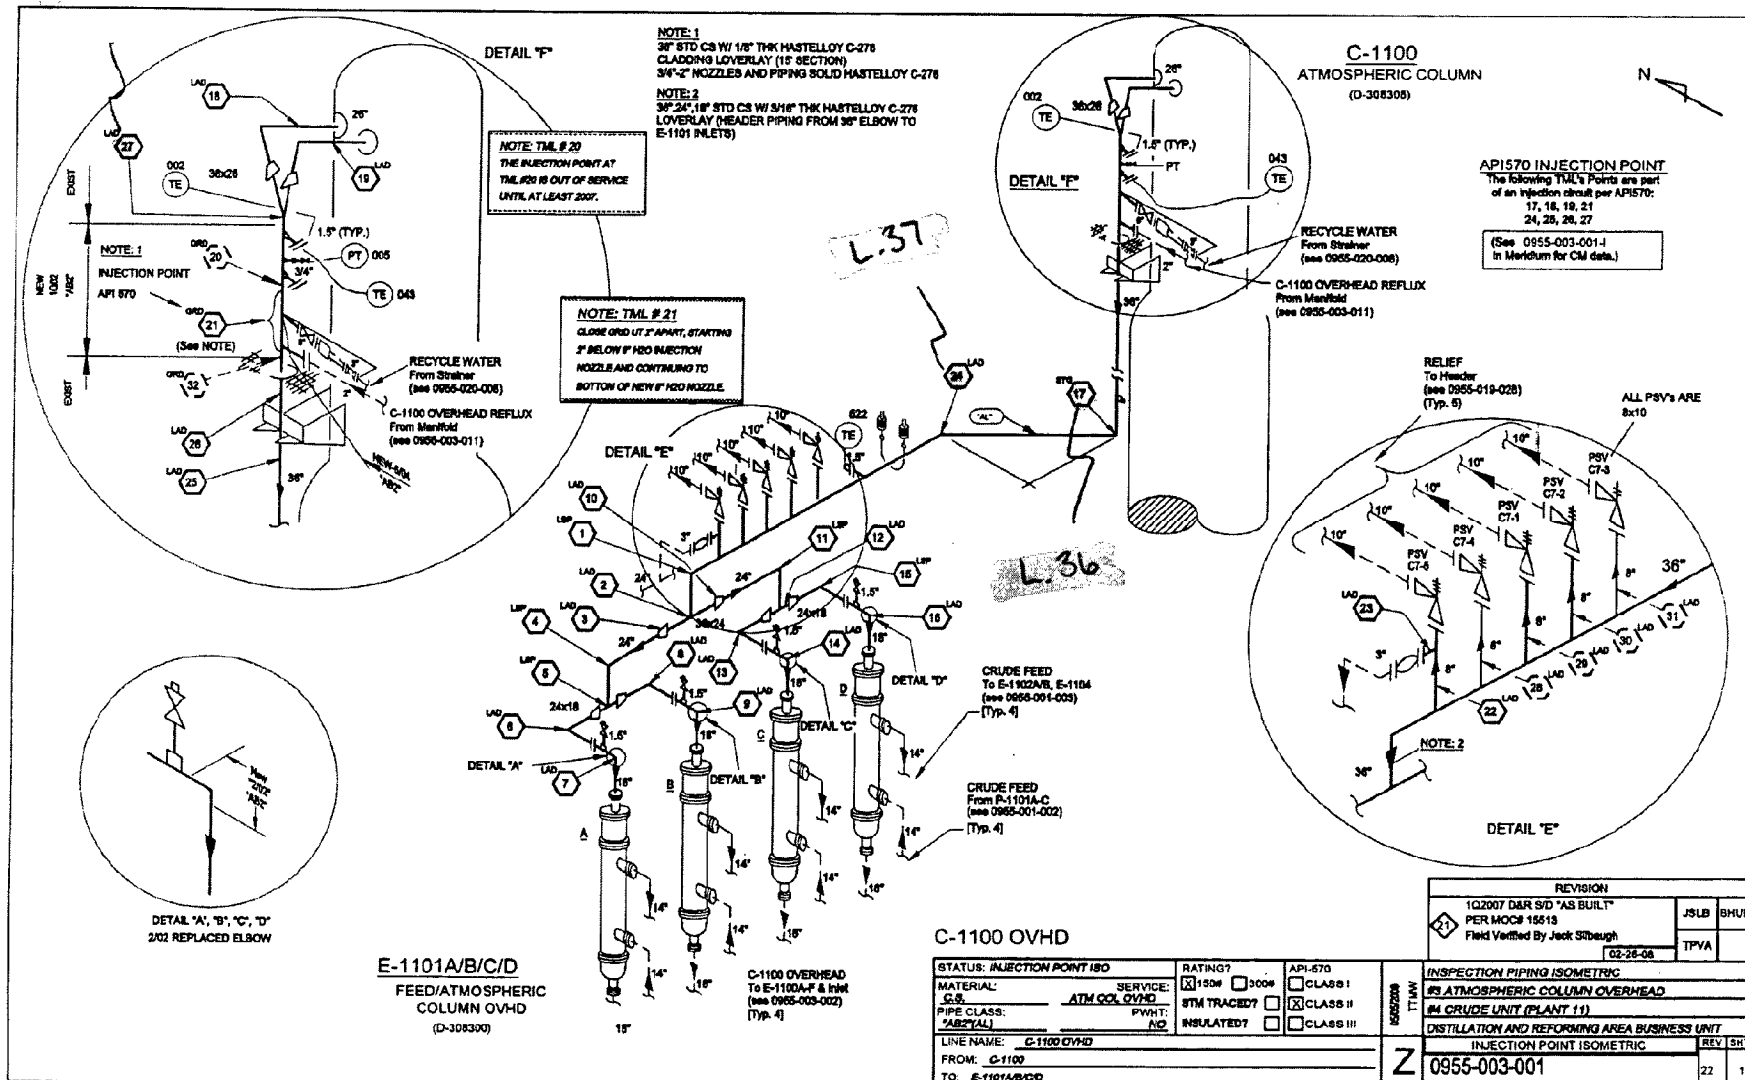
TML 27

TML	READING
17	0.36 LOW
24	0.37 LOW
27	0.27 LOW

LOOKING EAST.

Hand UT Scan was performed on the elbows due to geometry and inability of using the AUT machine. CML 27 at the Y connection near the top of C-1100 above the hastelloy overlay has an area that is corroding at 0.007" per year short term and a remaining life of 17 years. We re-inspect this area every 3 years because it is an injection point and we will monitor as needed. There is no recommendation for the Oct. 2011 event at this time.

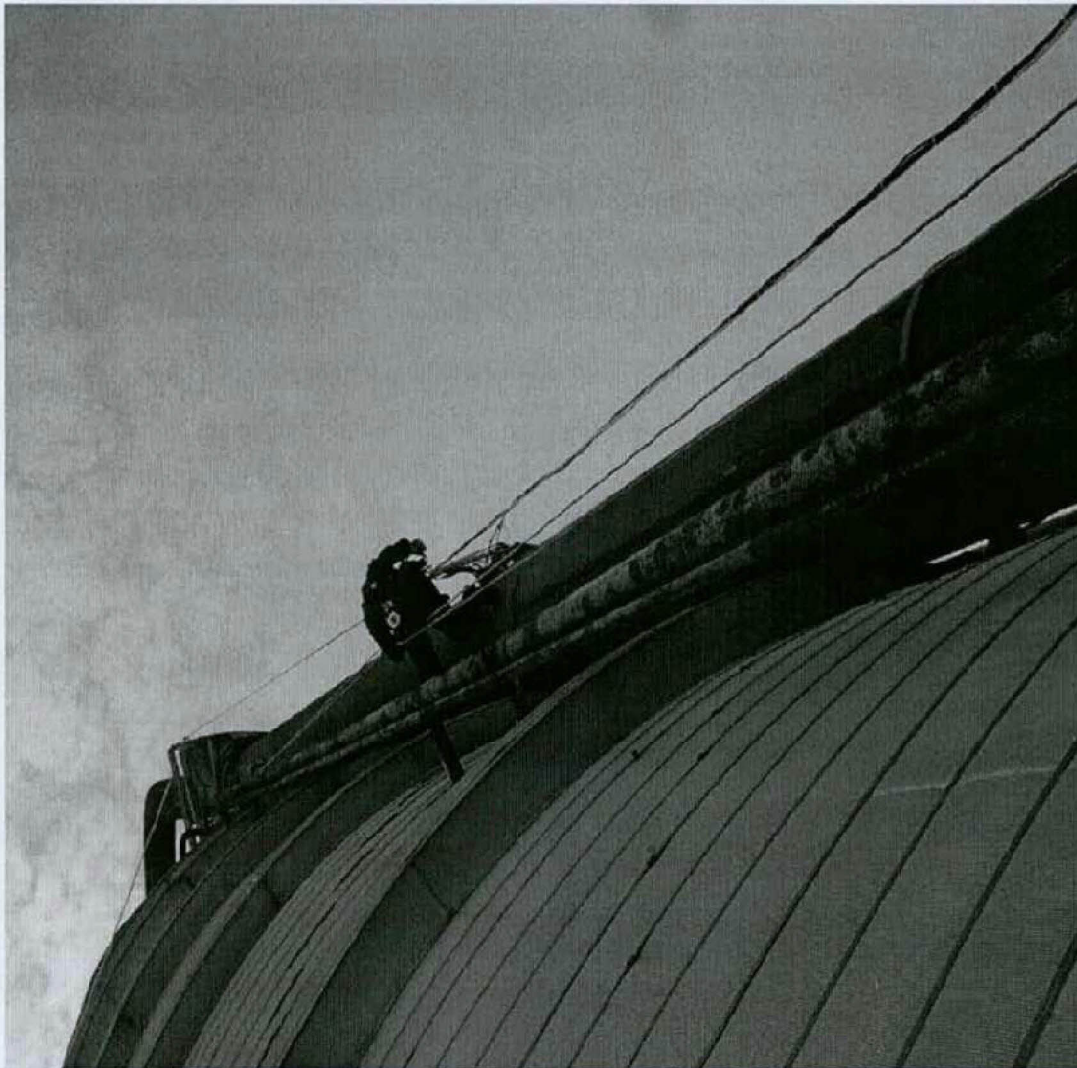
CRUDE OVERHEAD LINE VERTICAL SECTION (SECTION #1)

After the AUT data was acquired and analyzed it is determined that corrosion exists in all areas scanned.. The low for all scans is a 0.302" found in scan F4. All low areas detected are determined to be actual corrosion and not laminar reflectors. *Note: There was no paint/coating on the pipe at time of inspection, but some rust/scale was noticed. Minimum thickness, average thickness and scan dimensions for each scan are noted below:

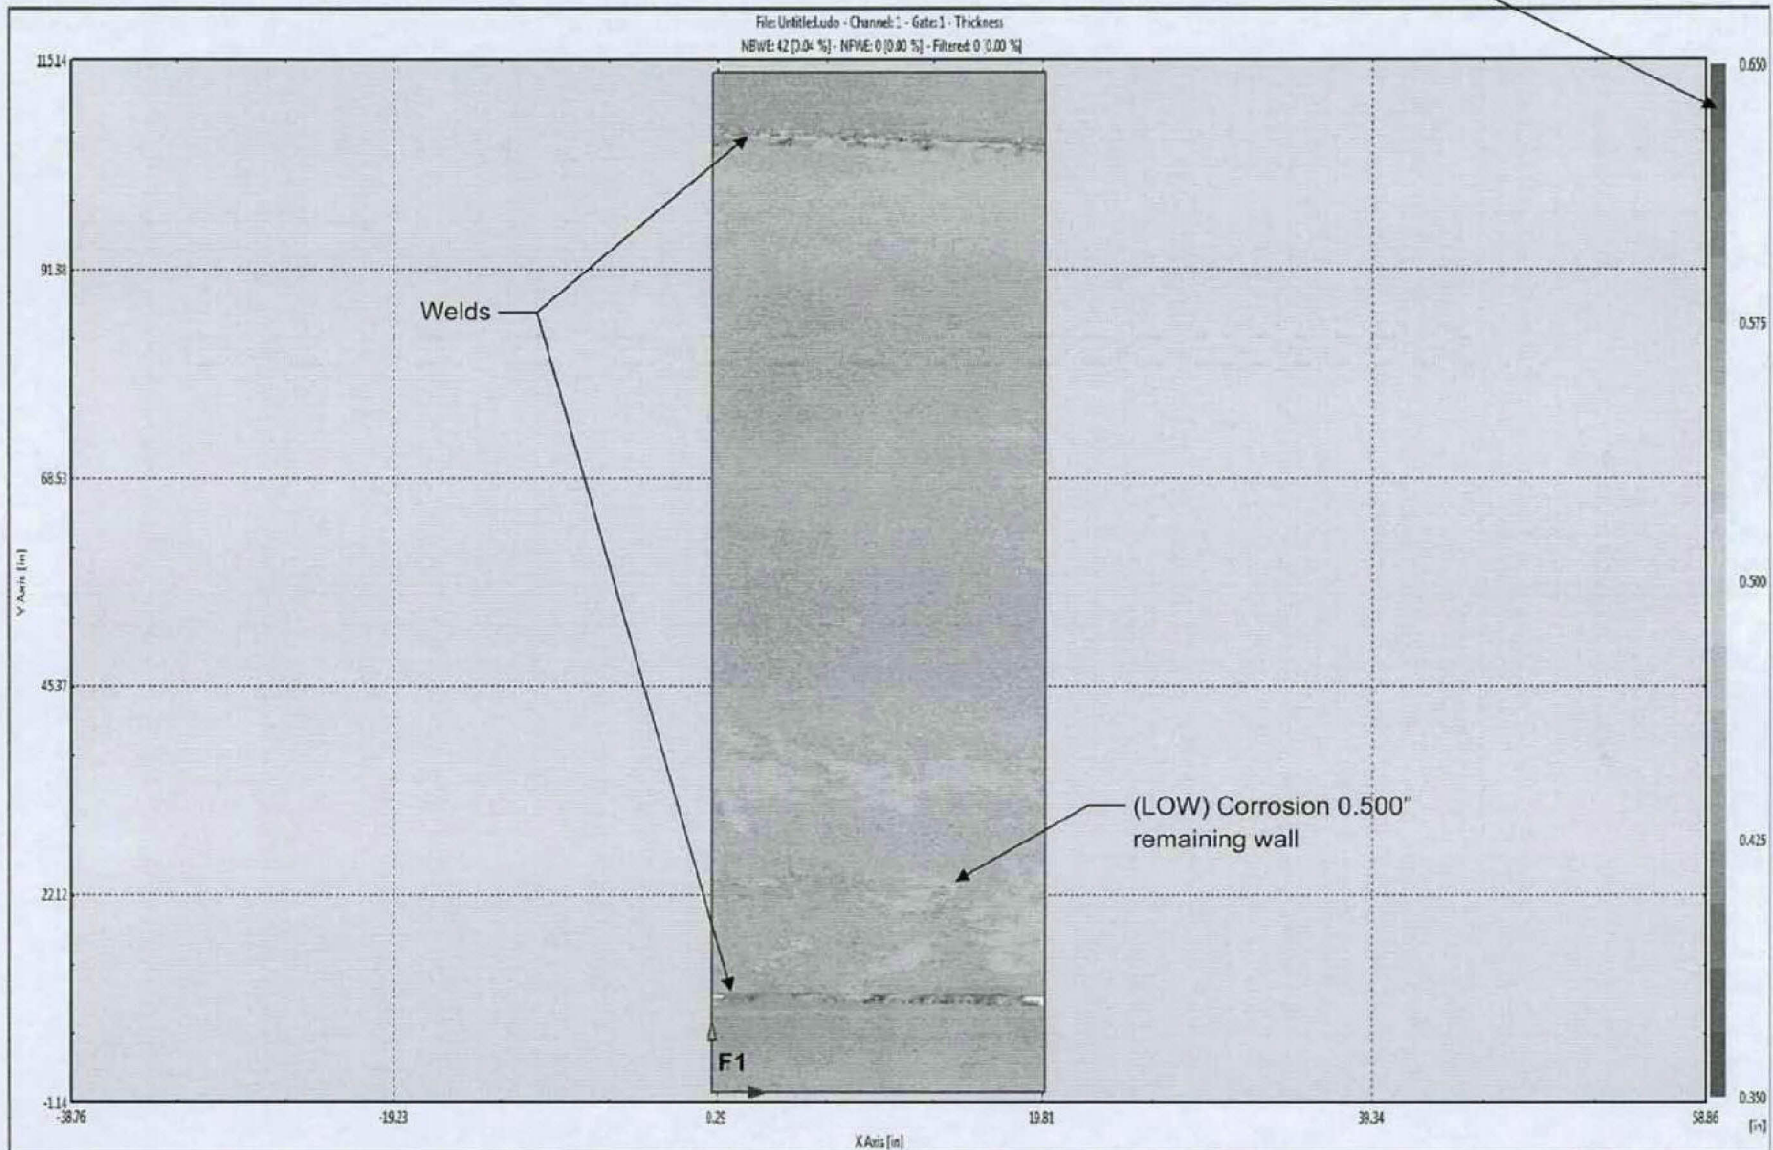
CRUDE OVERHEAD LINE SECTION #1 (SCAN F1)

Note: Scan F1 had to be separated from the merged C-scan image, due to the dramatic thickness change caused by the Hastelloy liner.

Scan #	Minimum Thickness	Average Thickness	Scan Lengths	Scan Widths
F1	0.500"	0.548"	114.0"	20.0"
F2	0.328"	0.383"	114.0"	20.0"
F3	0.328"	0.380"	92.0"	20.0"
F4	0.302"	0.355"	70.5."	20.0"

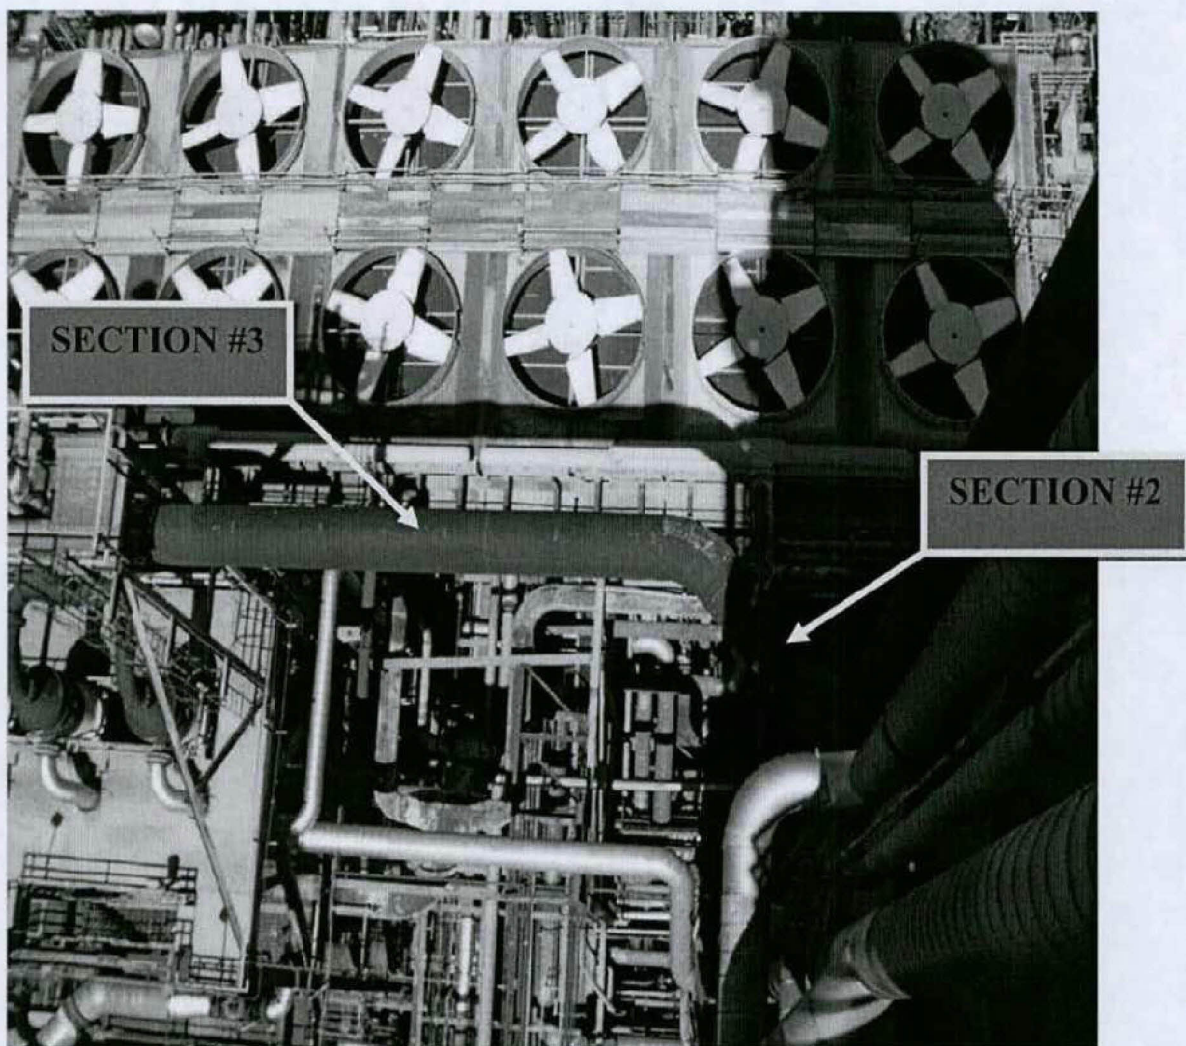
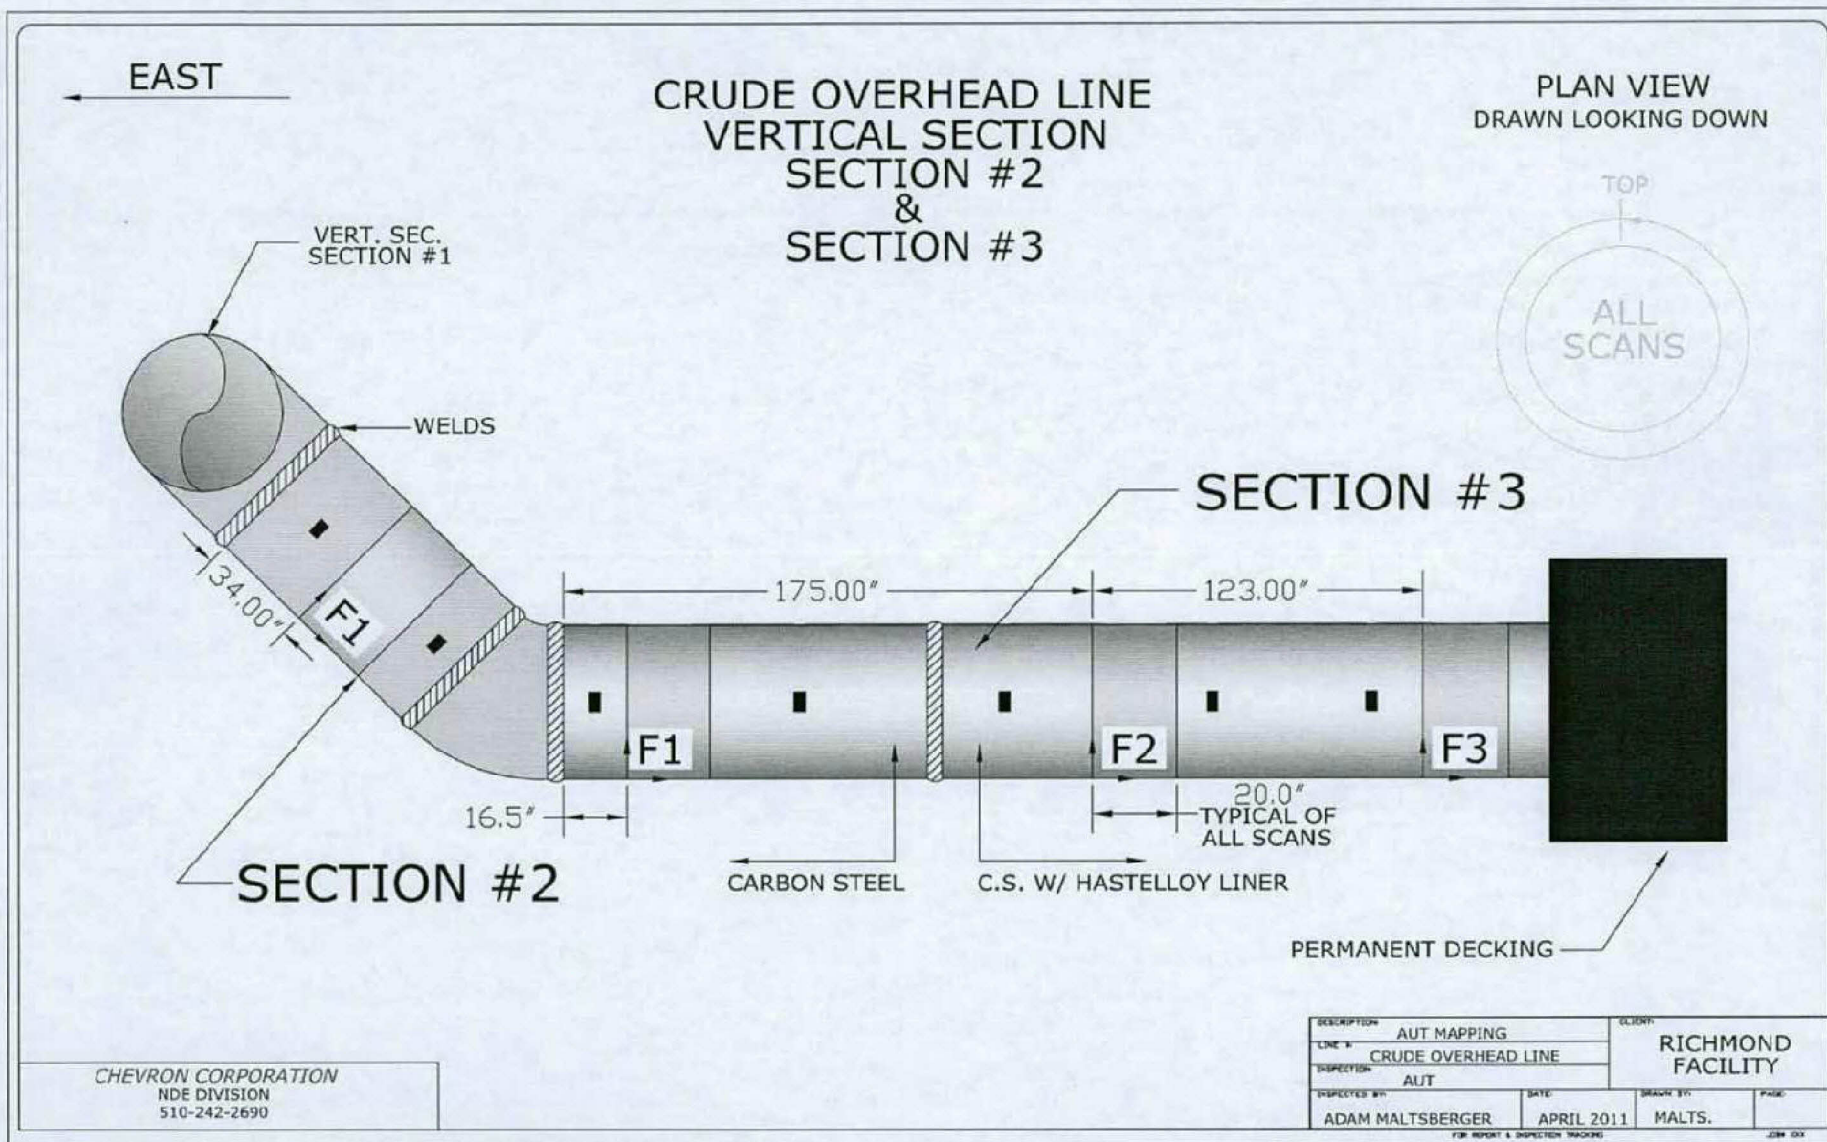
CRUDE OVERHEAD LINE HORIZONTAL SECTION (SECTION #2 & #3)

After the AUT data was acquired and analyzed it is determined that corrosion exists in the area scanned. The low for this scan is a 0.318". All low areas detected are determined to be actual corrosion and not laminar reflectors. *Note: There was no paint/coating on the pipe at time of inspection, but some rust/scale was noticed. Minimum thickness, average thickness and scan dimensions for each scan are noted below:

After the AUT data was acquired and analyzed it is determined that corrosion exists in all areas scanned. The low for all scans is a 0.297" found in scan F1. All low areas detected are determined to be actual corrosion and not laminar reflectors. *Note: There was no paint/coating on the pipe at time of inspection, but some rust/scale was noticed. Minimum thickness, average thickness and scan dimensions for each scan are noted below:

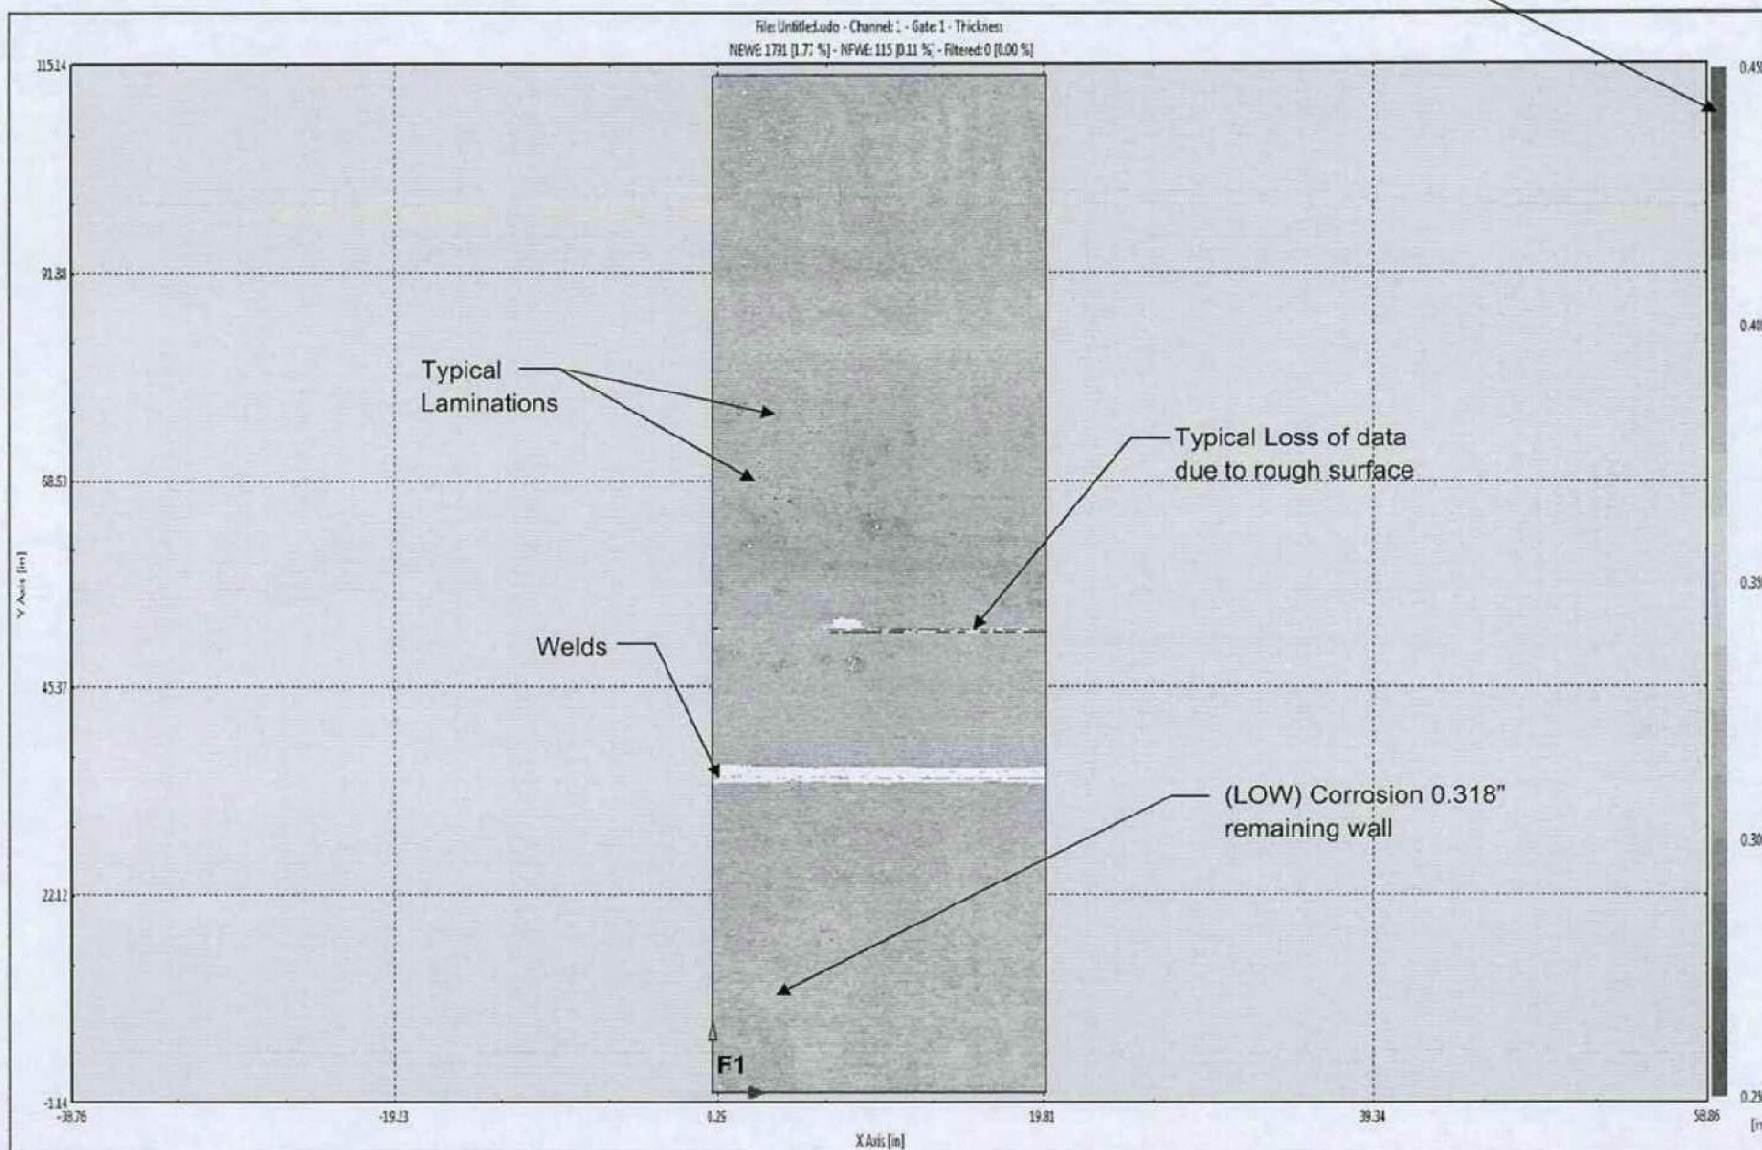
CRUDE OVERHEAD LINE SECTION #2

Scan #	Minimum Thickness	Average Thickness	Scan Lengths	Scan Widths
F1	0.318"	0.379"	114.0"	20.0"

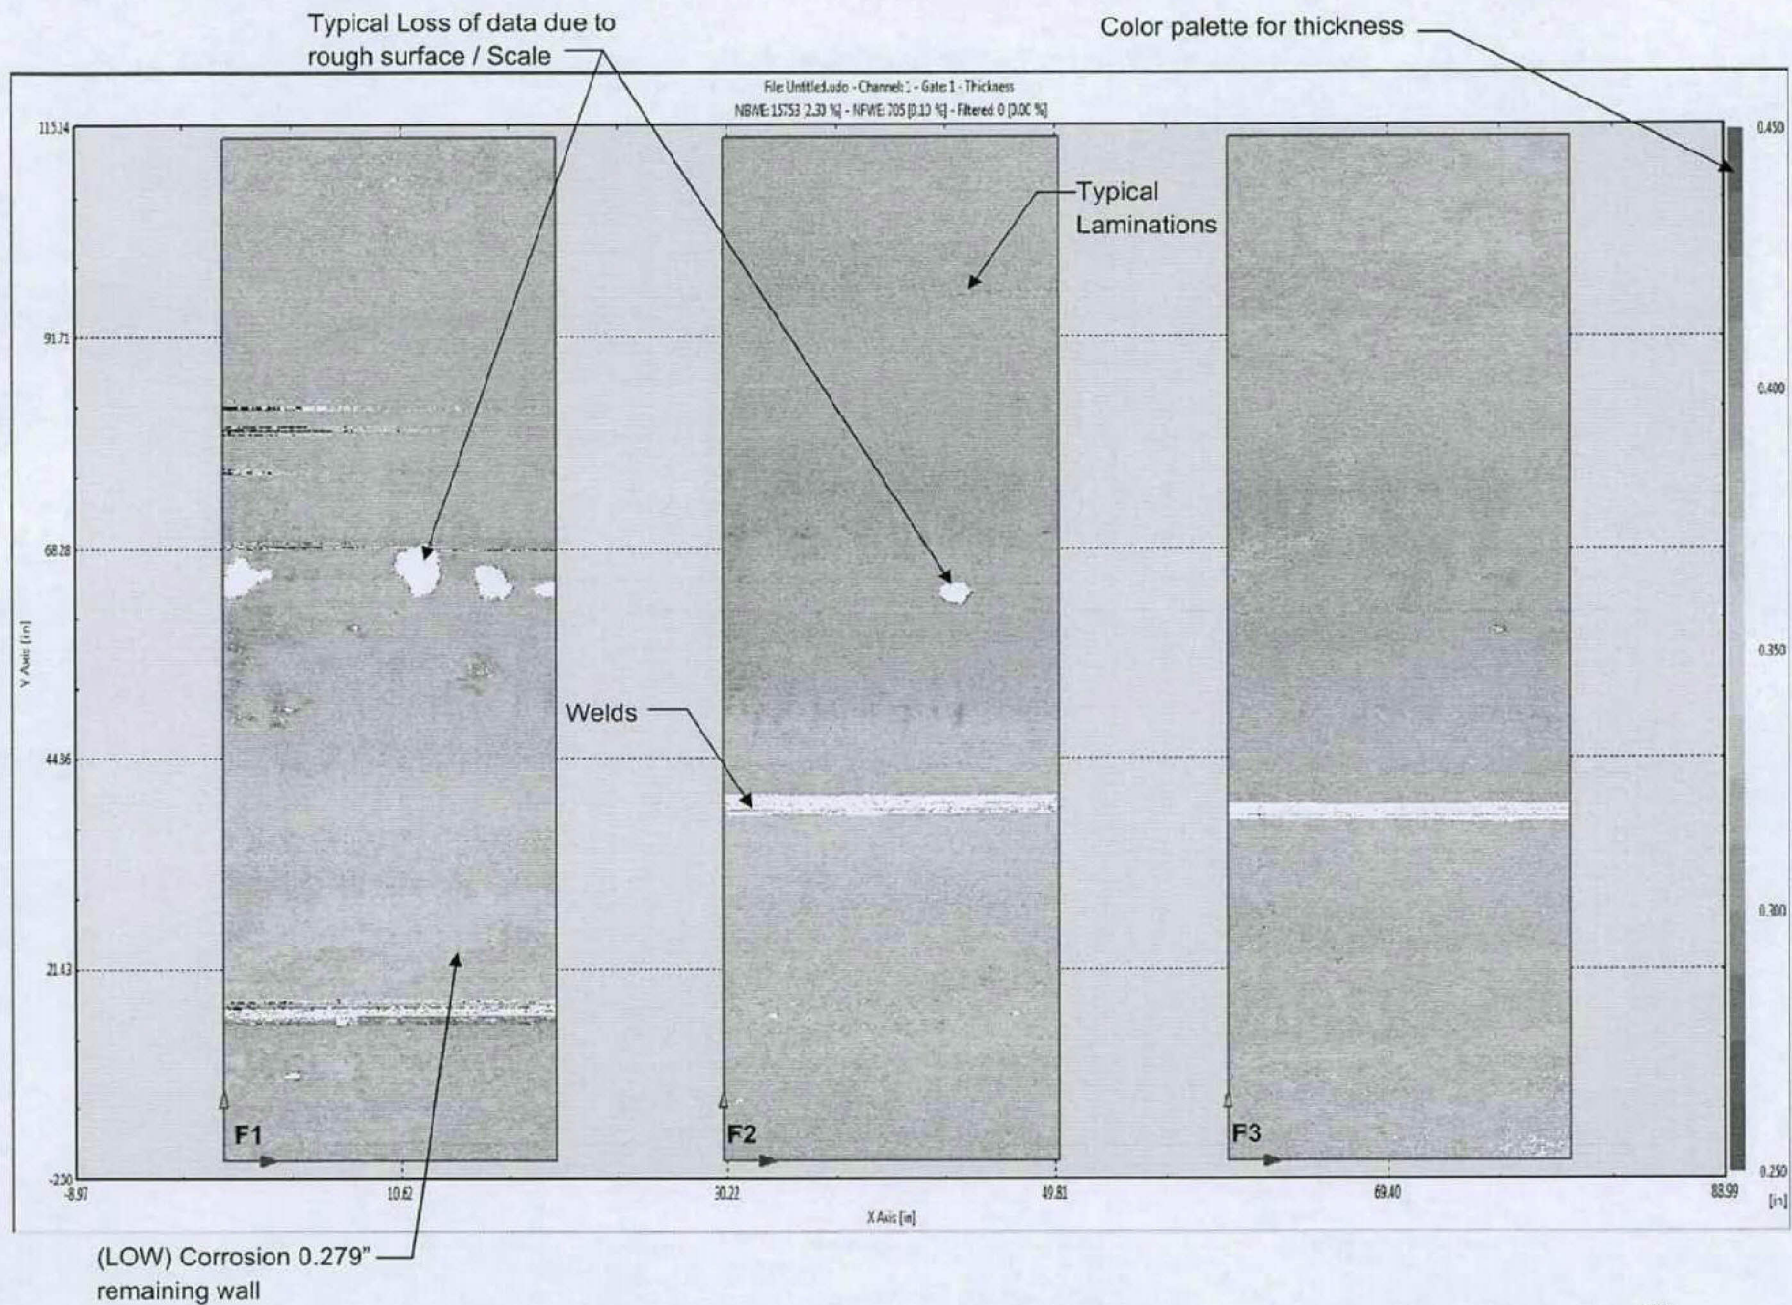
CRUDE OVERHEAD LINE SECTION #3

Scan #	Minimum Thickness	Average Thickness	Scan Lengths	Scan Widths
F1	0.297"	0.377"	114.0"	20.0"
F2	0.312"	0.379"	114.0"	20.0"
F3	0.329"	0.380"	114.0"	20.0"

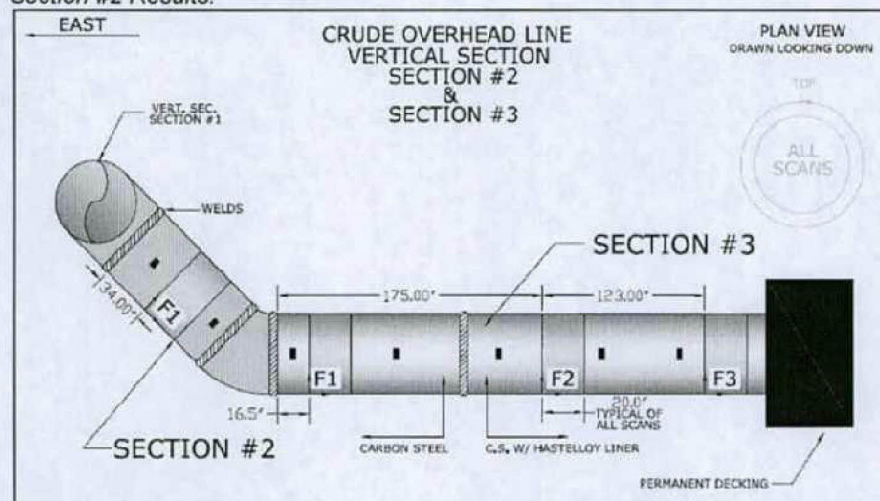
Section #2 Results:

After the AUT data was acquired and analyzed it is determined that corrosion exists in the area scanned. The low for this scan is a 0.318". All low areas detected are determined to be actual corrosion and not laminar reflectors. *Note: There was no paint/coating on the pipe at time of inspection, but some rust/scale was noticed. Minimum thickness, average thickness and scan dimensions for each scan are noted below:

Scan #	Minimum Thickness	Average Thickness
--------	-------------------	-------------------

F1

0.318"

0.379"

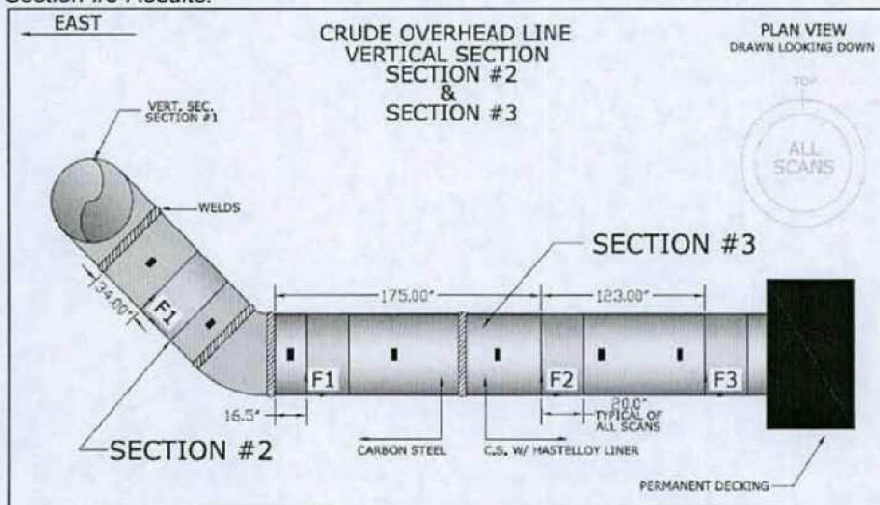
Section #3 Results:

After the AUT data was acquired and analyzed it is determined that corrosion exists in all areas scanned. The low for all scans is a 0.297" found in scan F1. All low areas detected are determined to be actual corrosion and not laminar reflectors. *Note: There was no paint/coating on the pipe at time of inspection, but some rust/scale was noticed. Minimum thickness, average thickness and scan dimensions for each scan are noted below:

Scan #	Minimum Thickness	Average Thickness
F1	0.297"	0.377"
F2	0.312"	0.379"
F3	0.329"	0.380"
